RESEARCH ARTICLE

FIB/SEM and SEM/EDS microstructural analysis of metal-ceramic and zirconia-ceramic interfaces

Massimi F¹, Merlati G², Sebastiani M¹, Battaini P³, Menghini P², Bemporad E¹

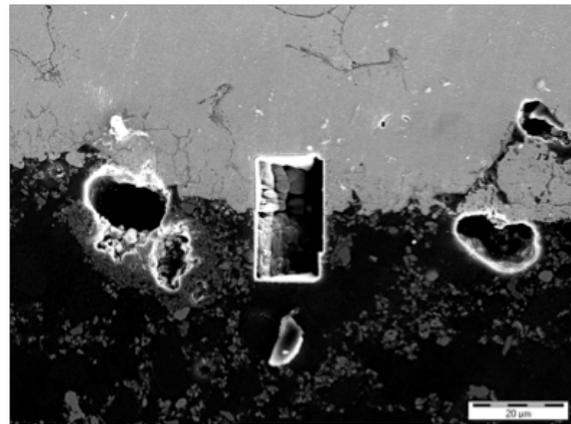
Fig. 7: despite the presence of many voids it was possible to perform the ion beam milling crossing the interface between IPS e.max® ZirCAD (up) and IPS e.max® ZirPress (down) (SEM, BSE, 1000X).
